Let There Be Light¹

Proposed New Lighting
St Mary the Virgin
Saffron Walden

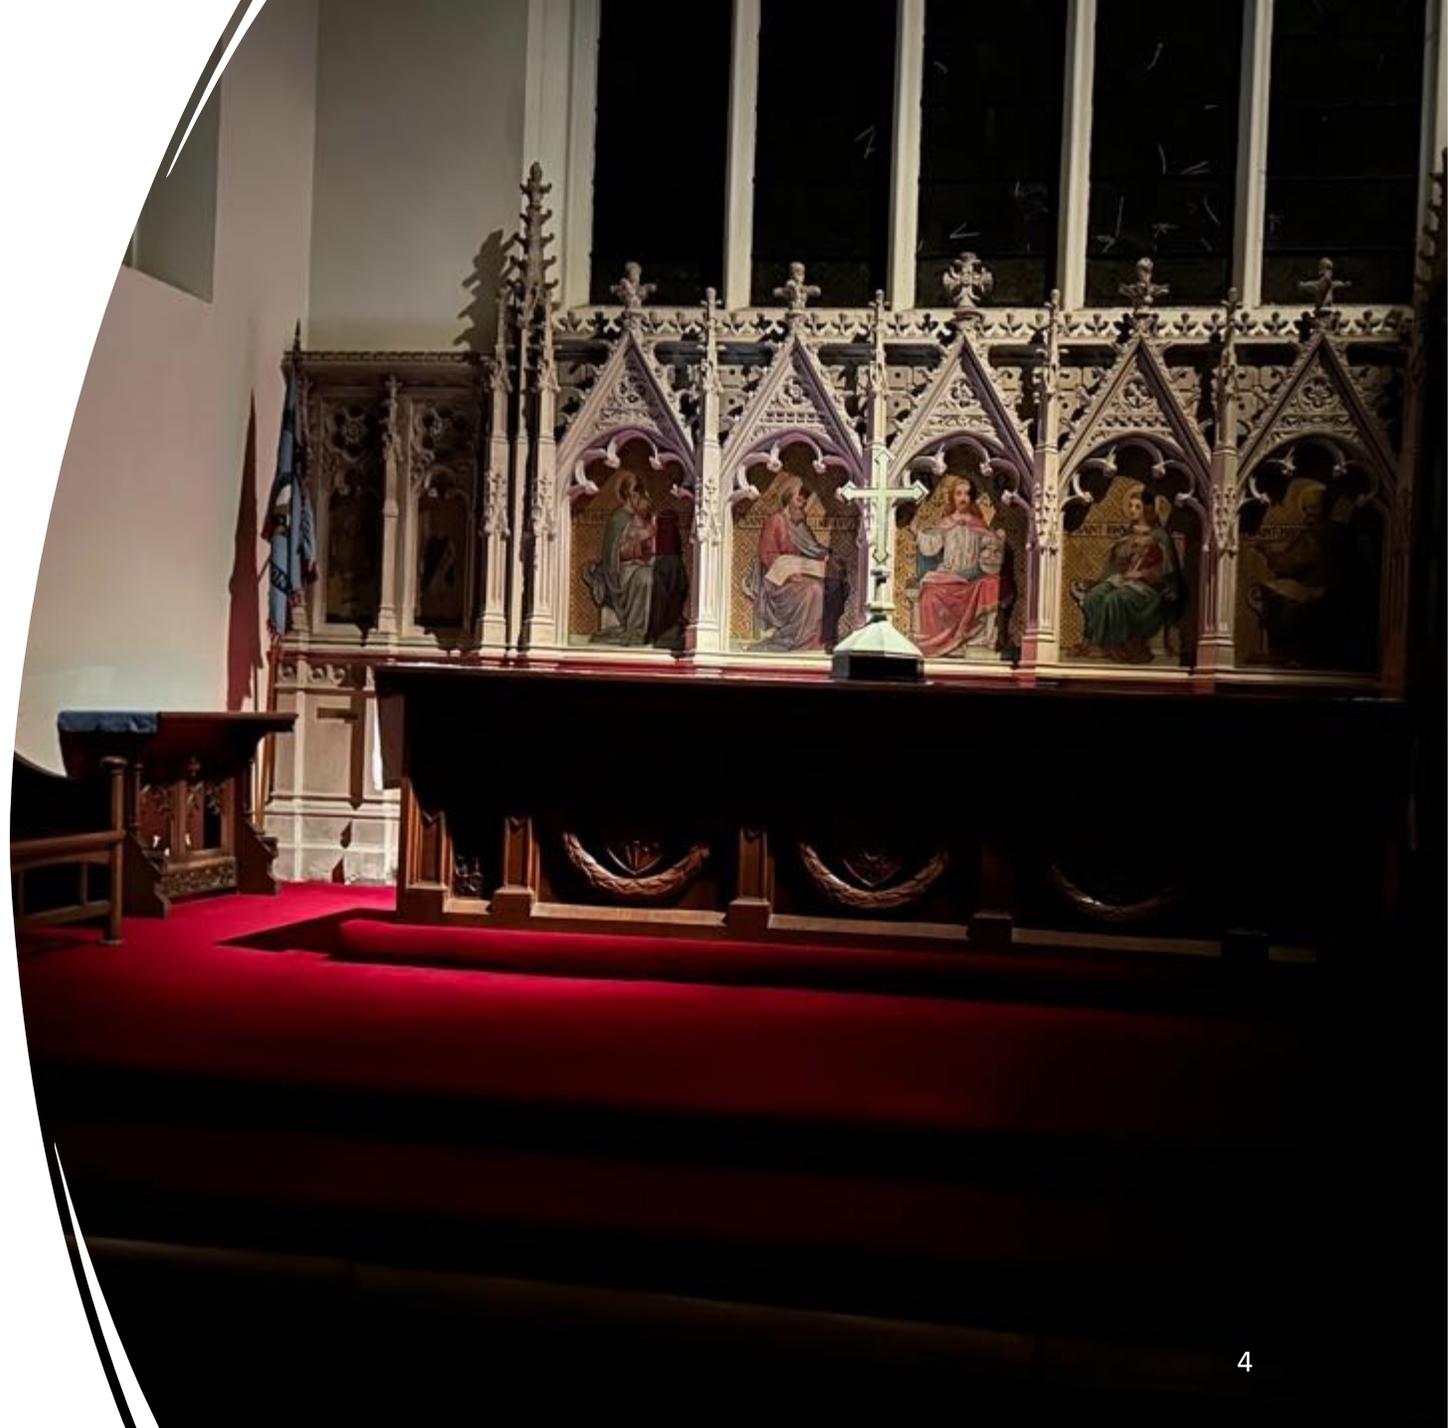
Current lighting is very old and failing

- The problem with the lighting which has failed is with the electronics in the fittings which power the bulbs

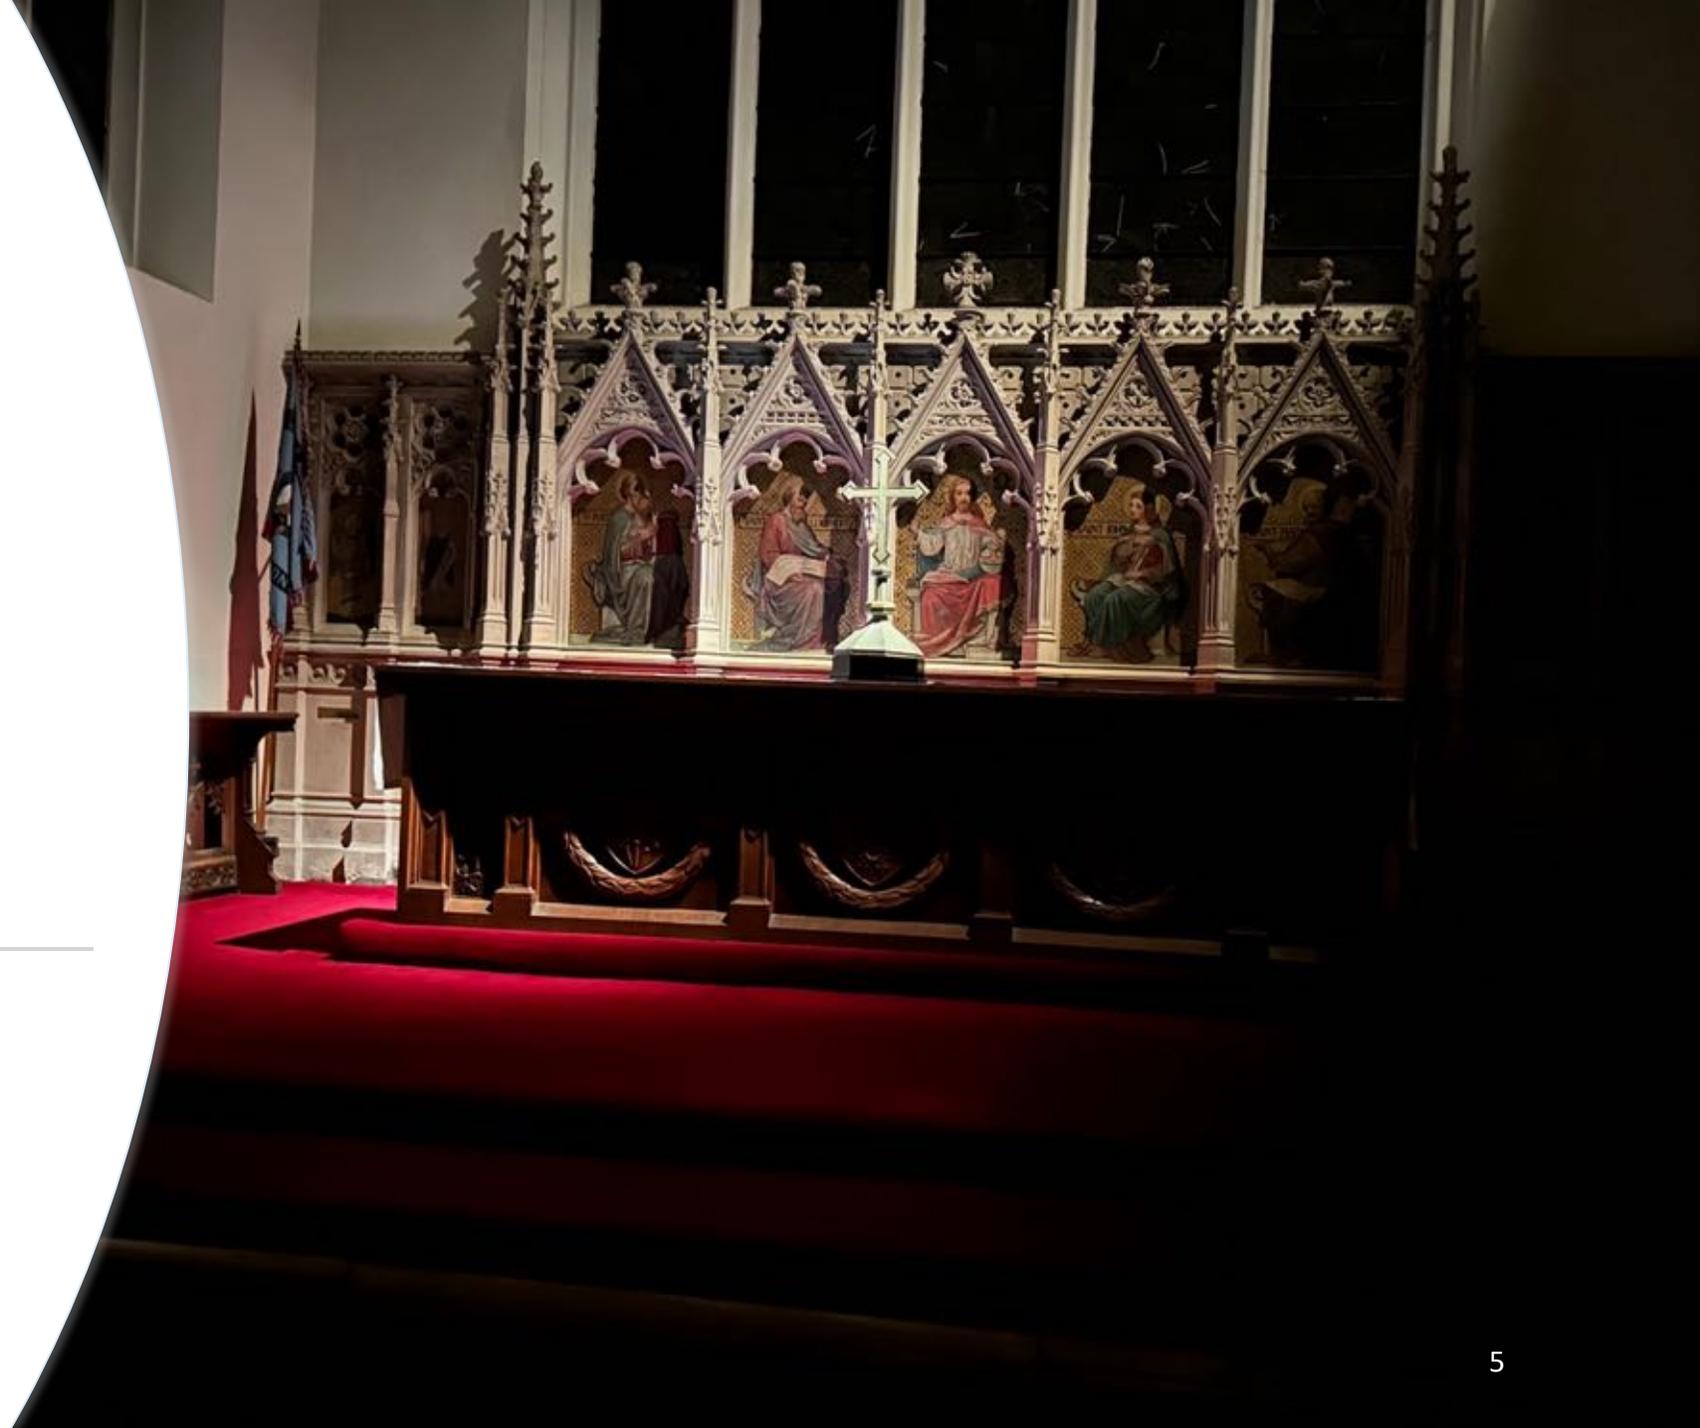
Main Altar

Only partially lit due
to failed spotlights

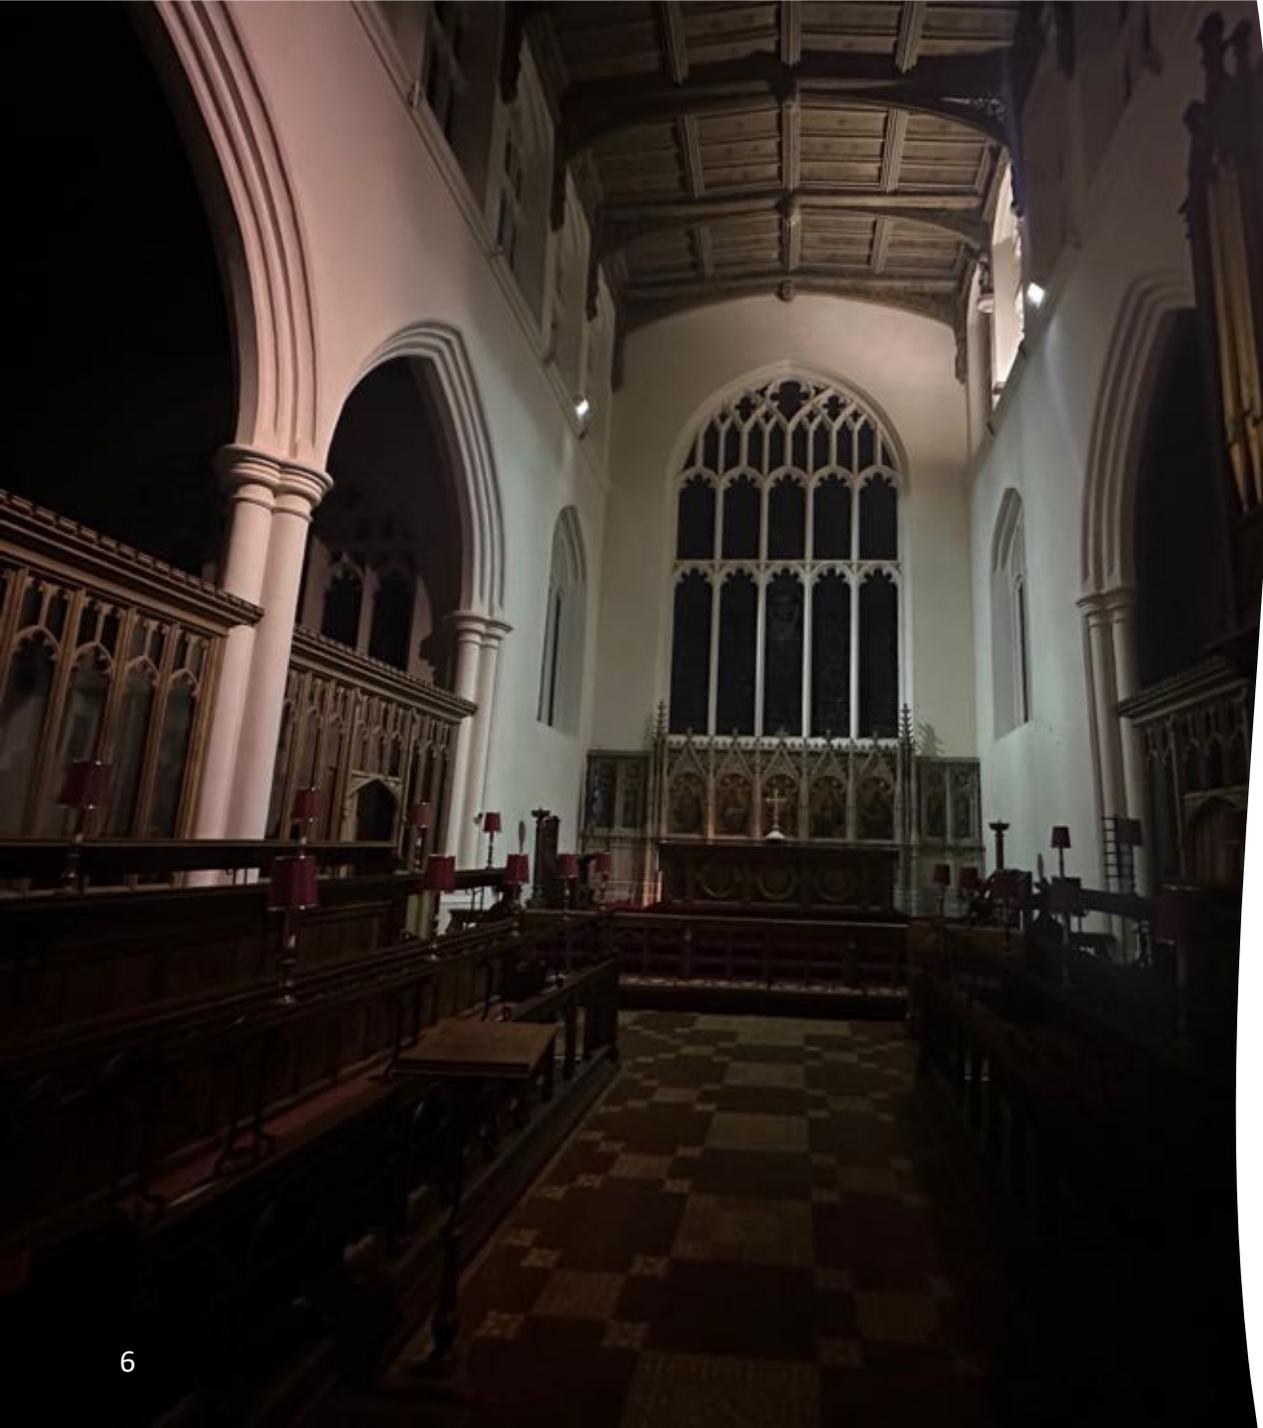
Sanctuary and Chancel are dim

- Many failed lights
- Difficult to access safely

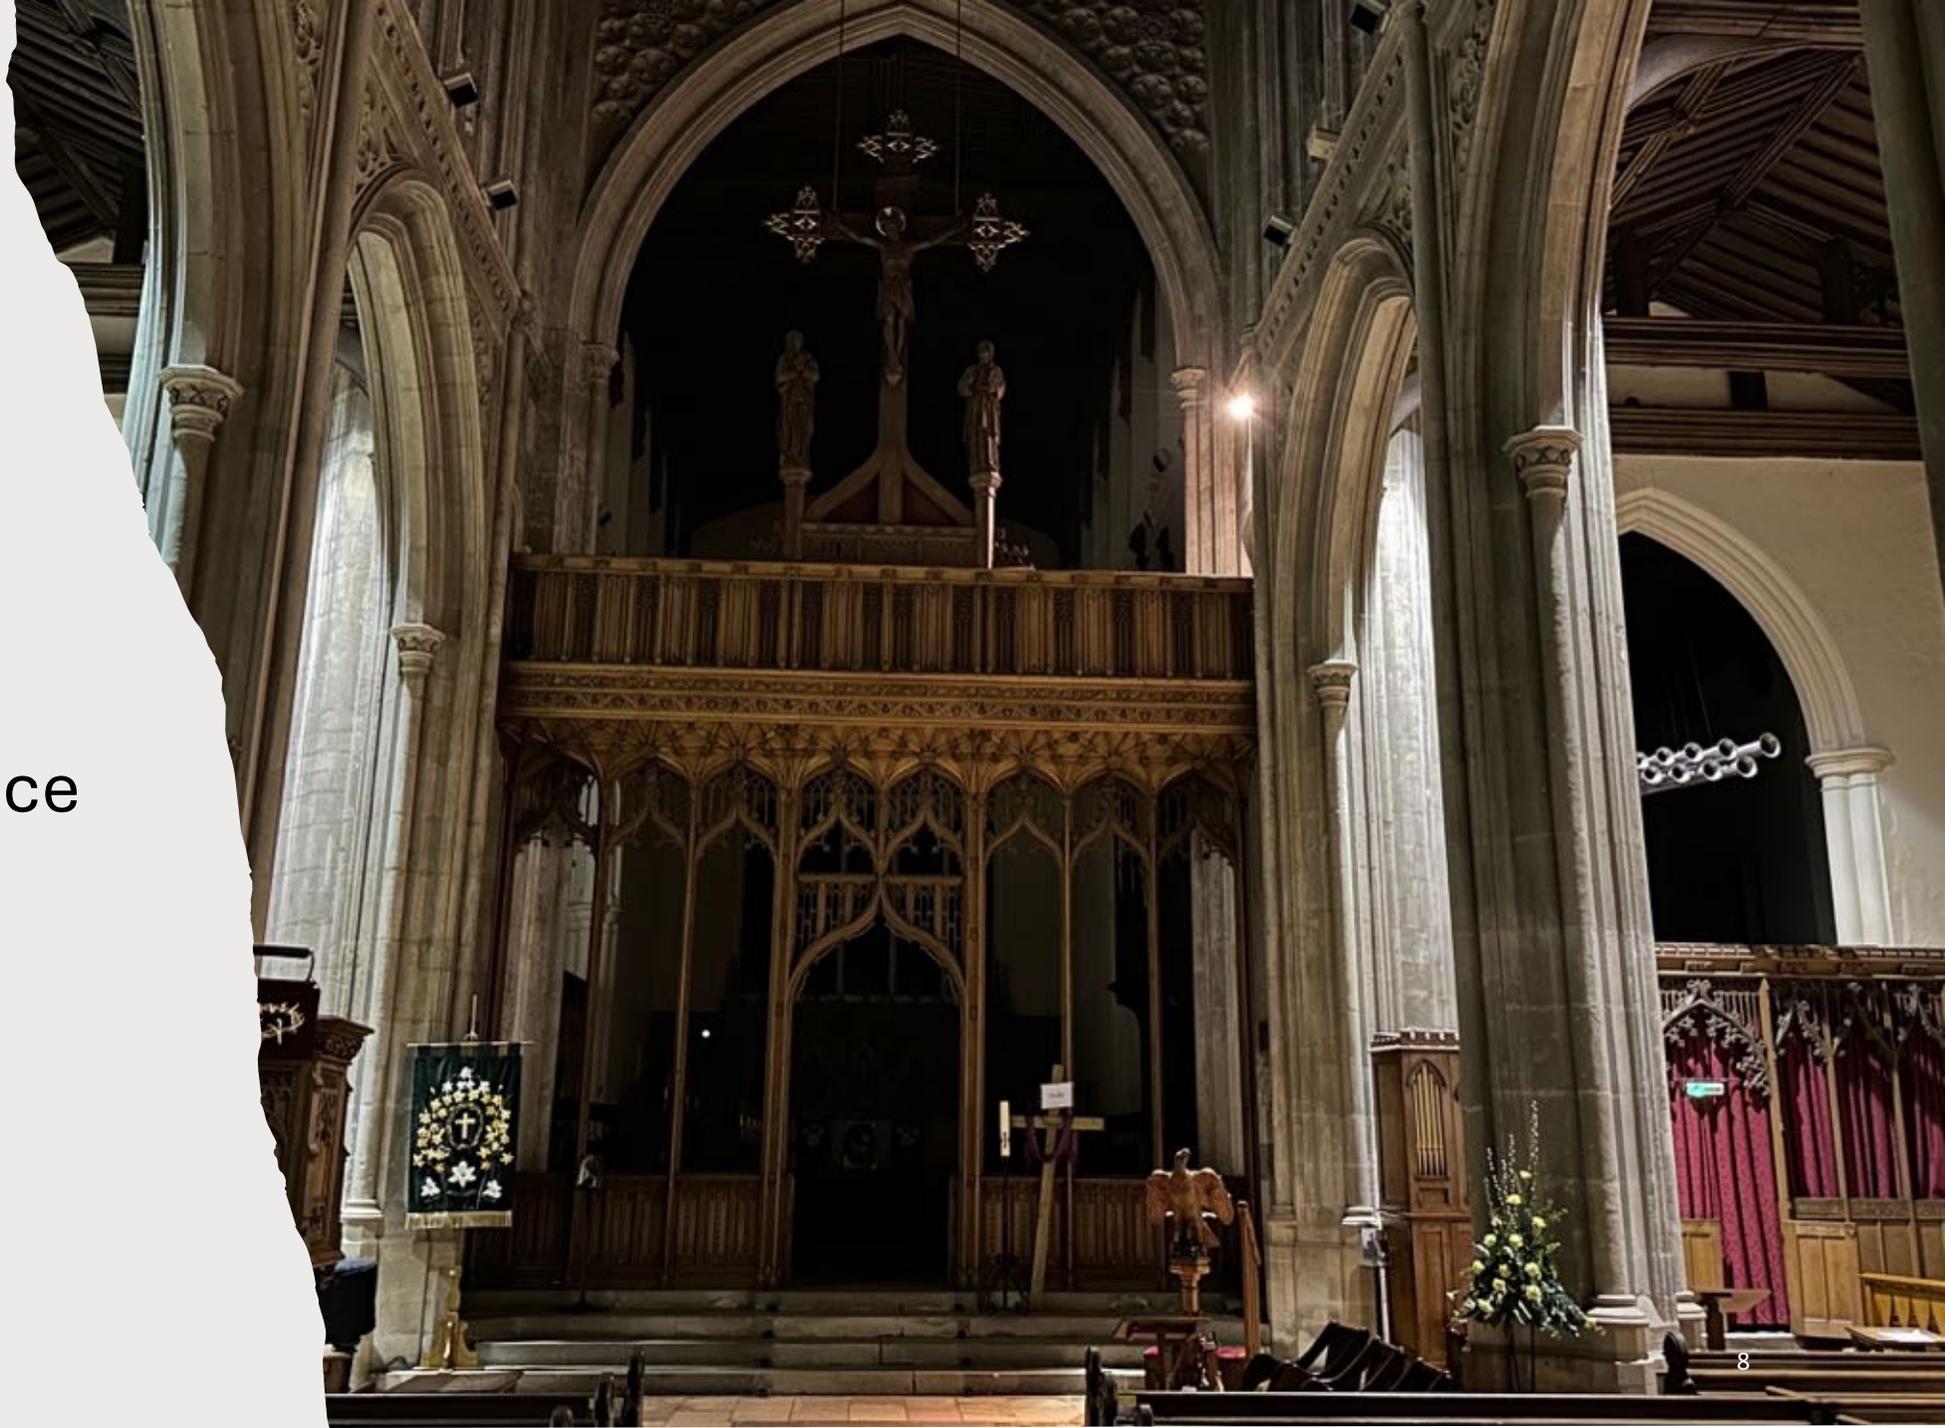
Rood Screen Cross

- Has not been spotlighted since 2019
- Especially noticeable during Easter and Christmas services

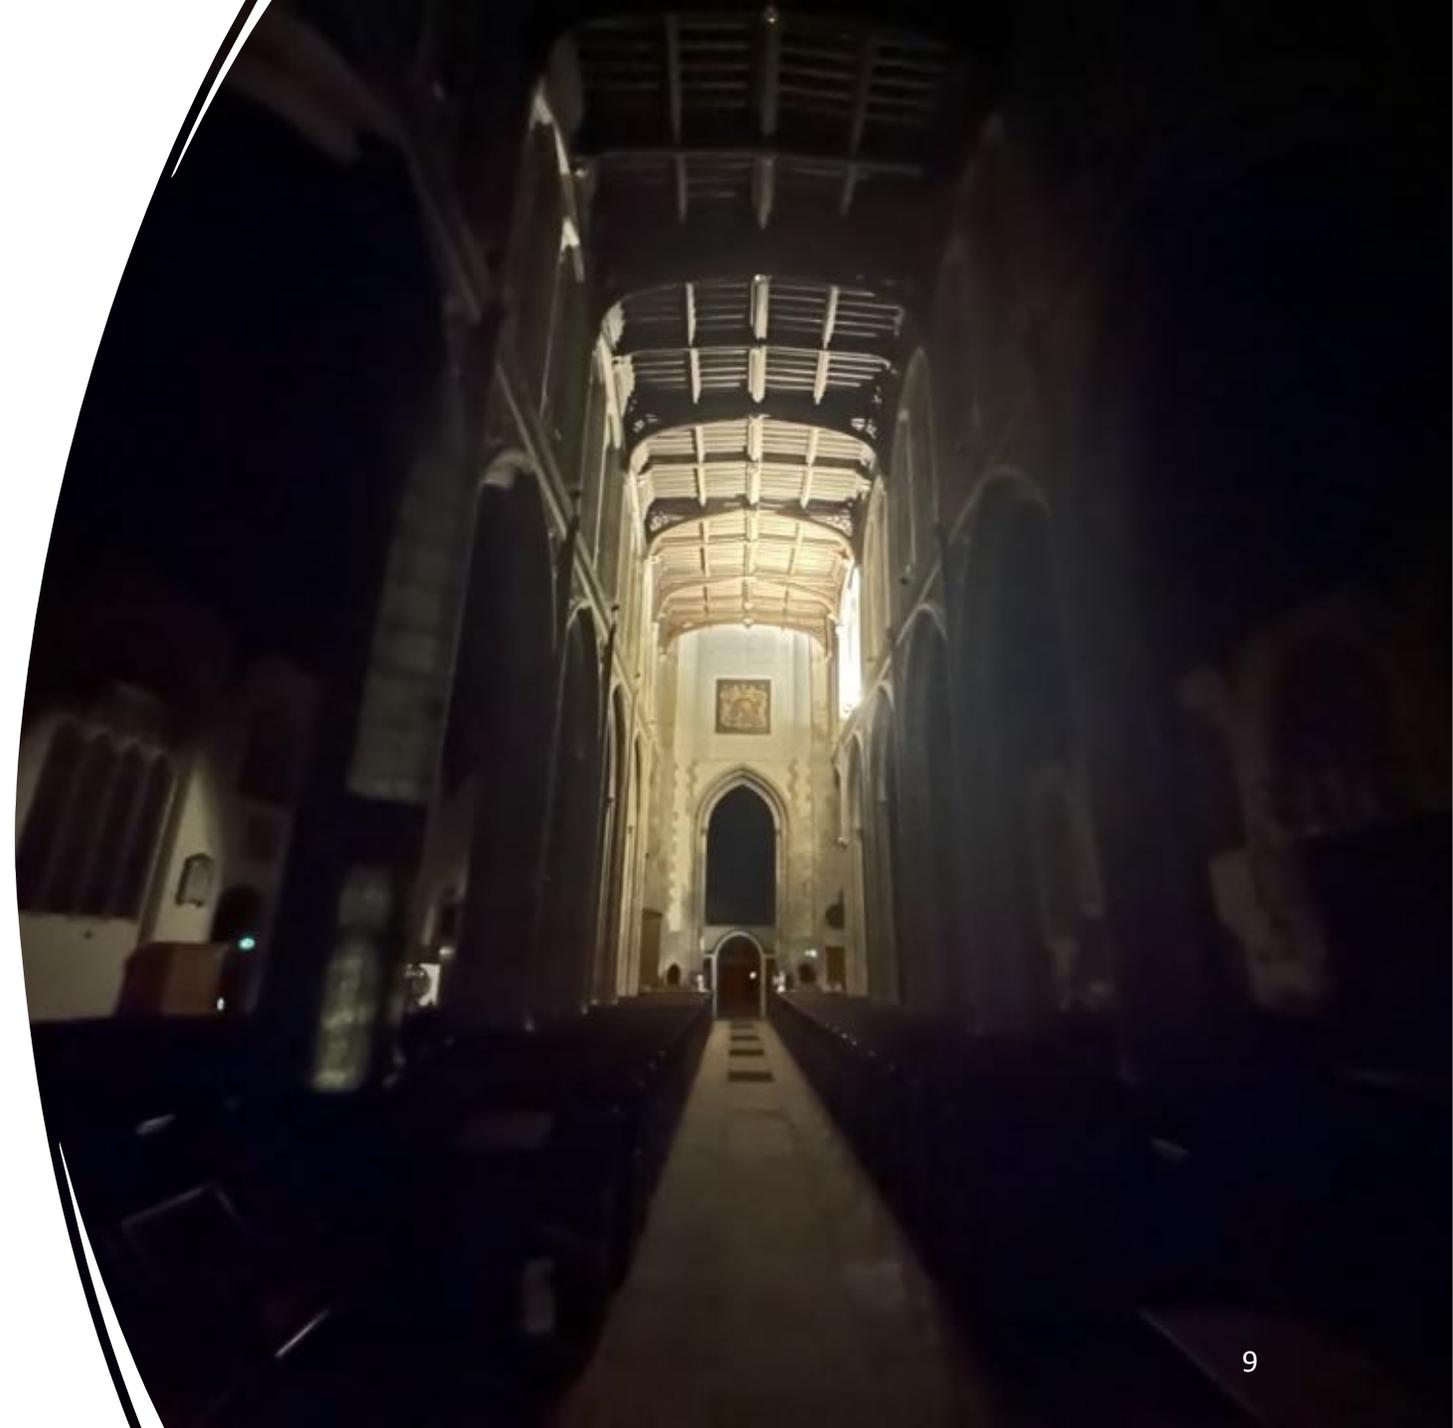
Uplighters in Nave – North Side

- One uplighter on north side
- There should be six

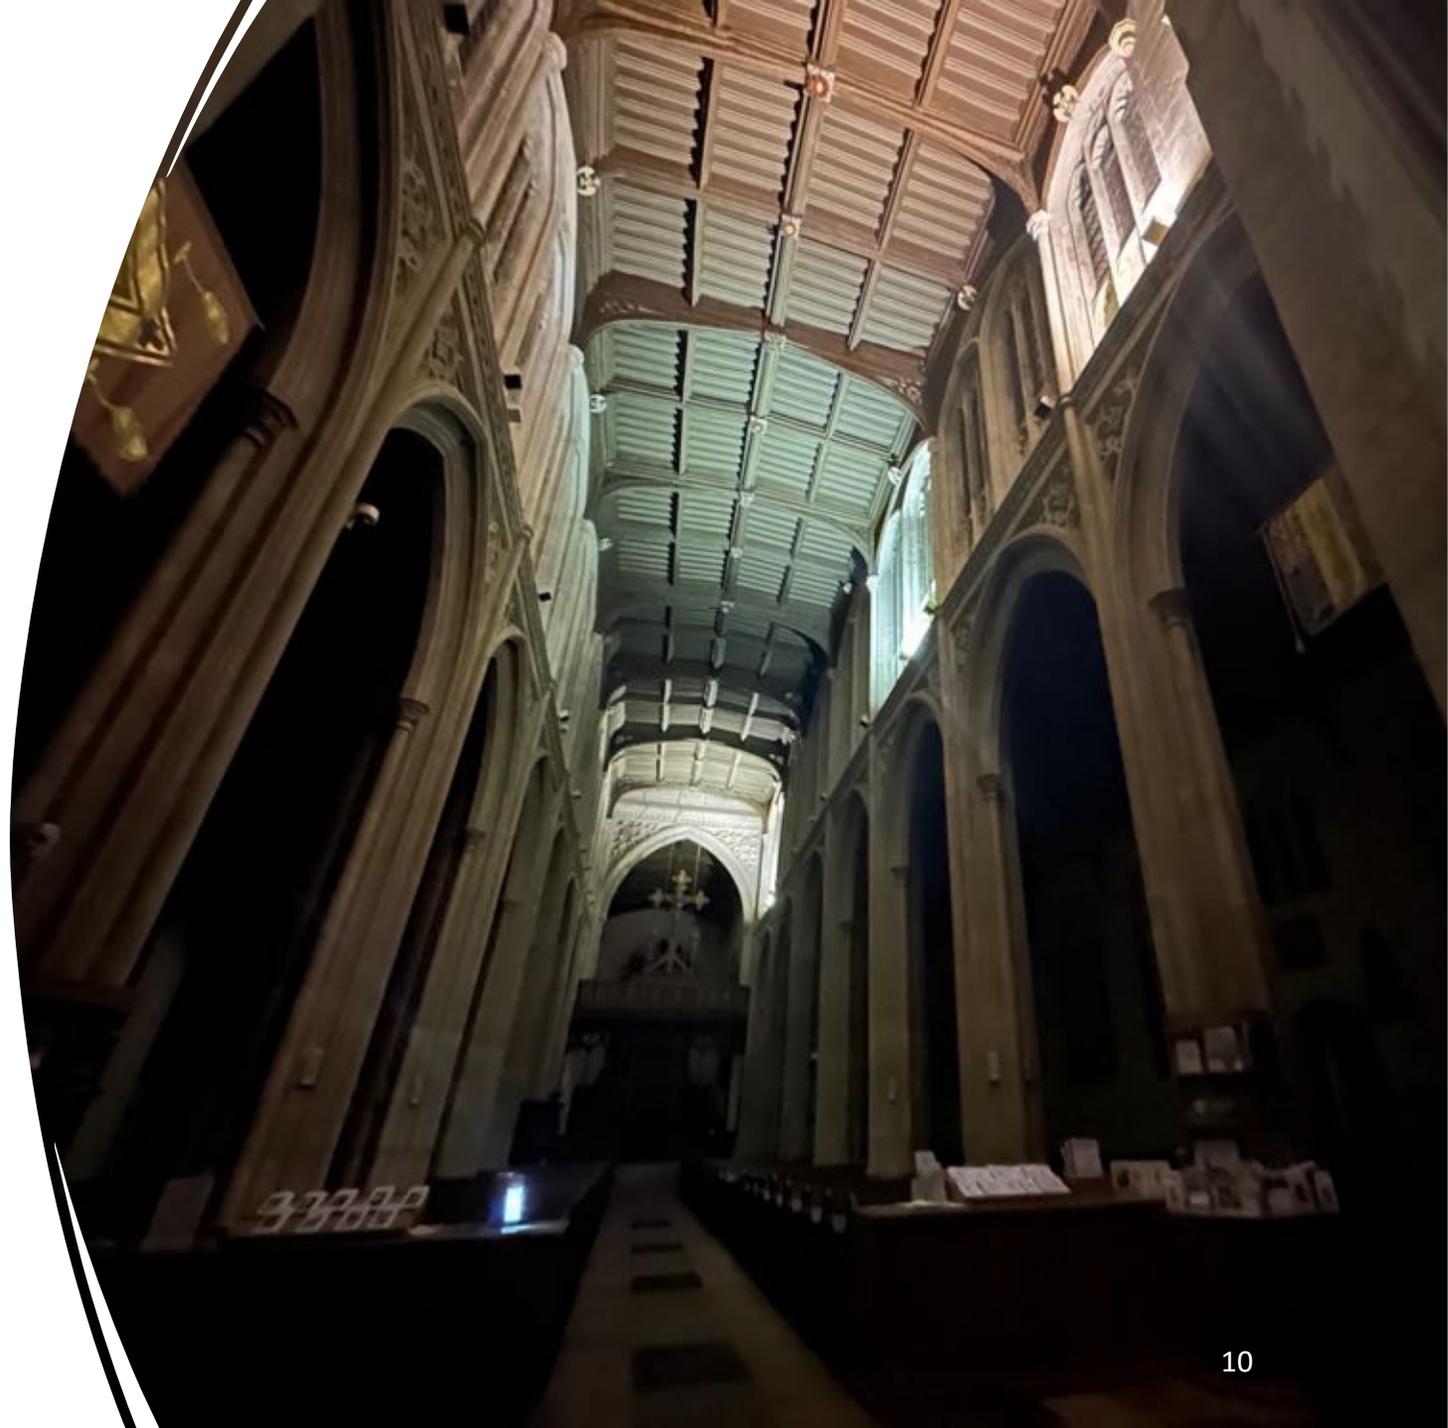
Uplighters in Nave – South Side

- Three uplighters on south side
- There should be six

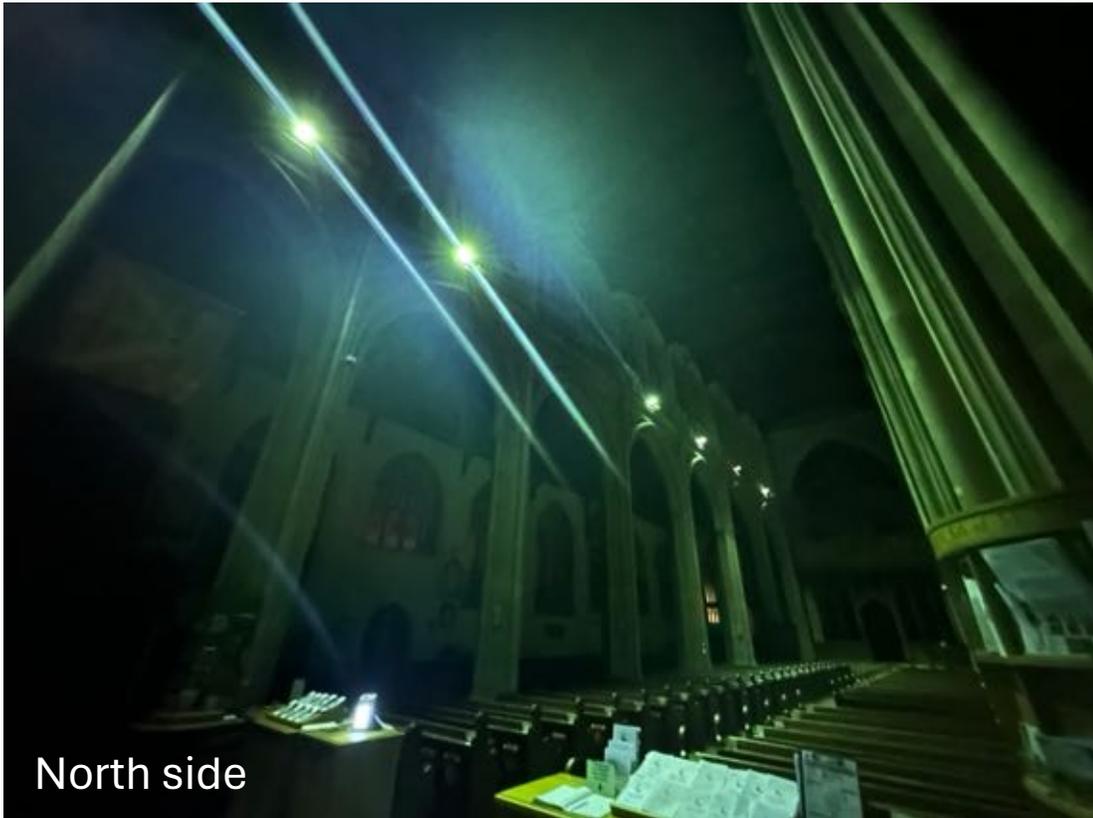
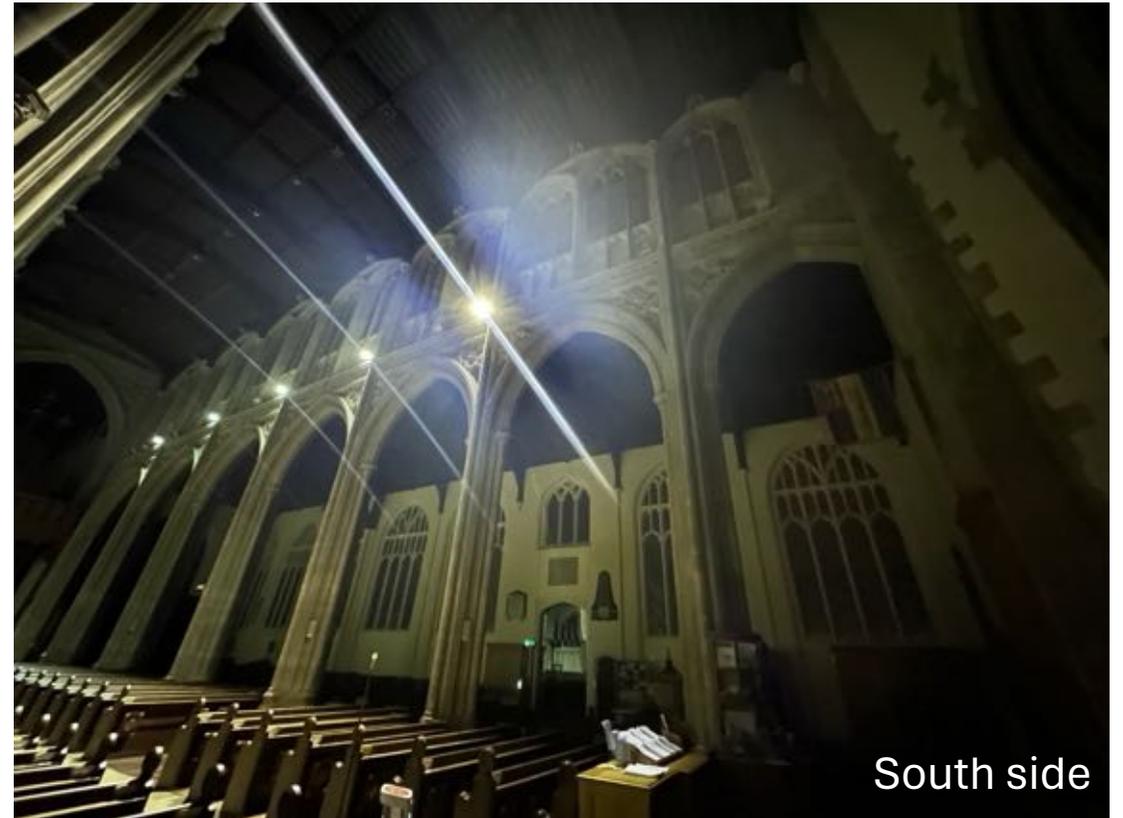
Downlighters in the nave

- Only a few have failed to date
- When switched on, these hide that a large number of the uplighters have failed

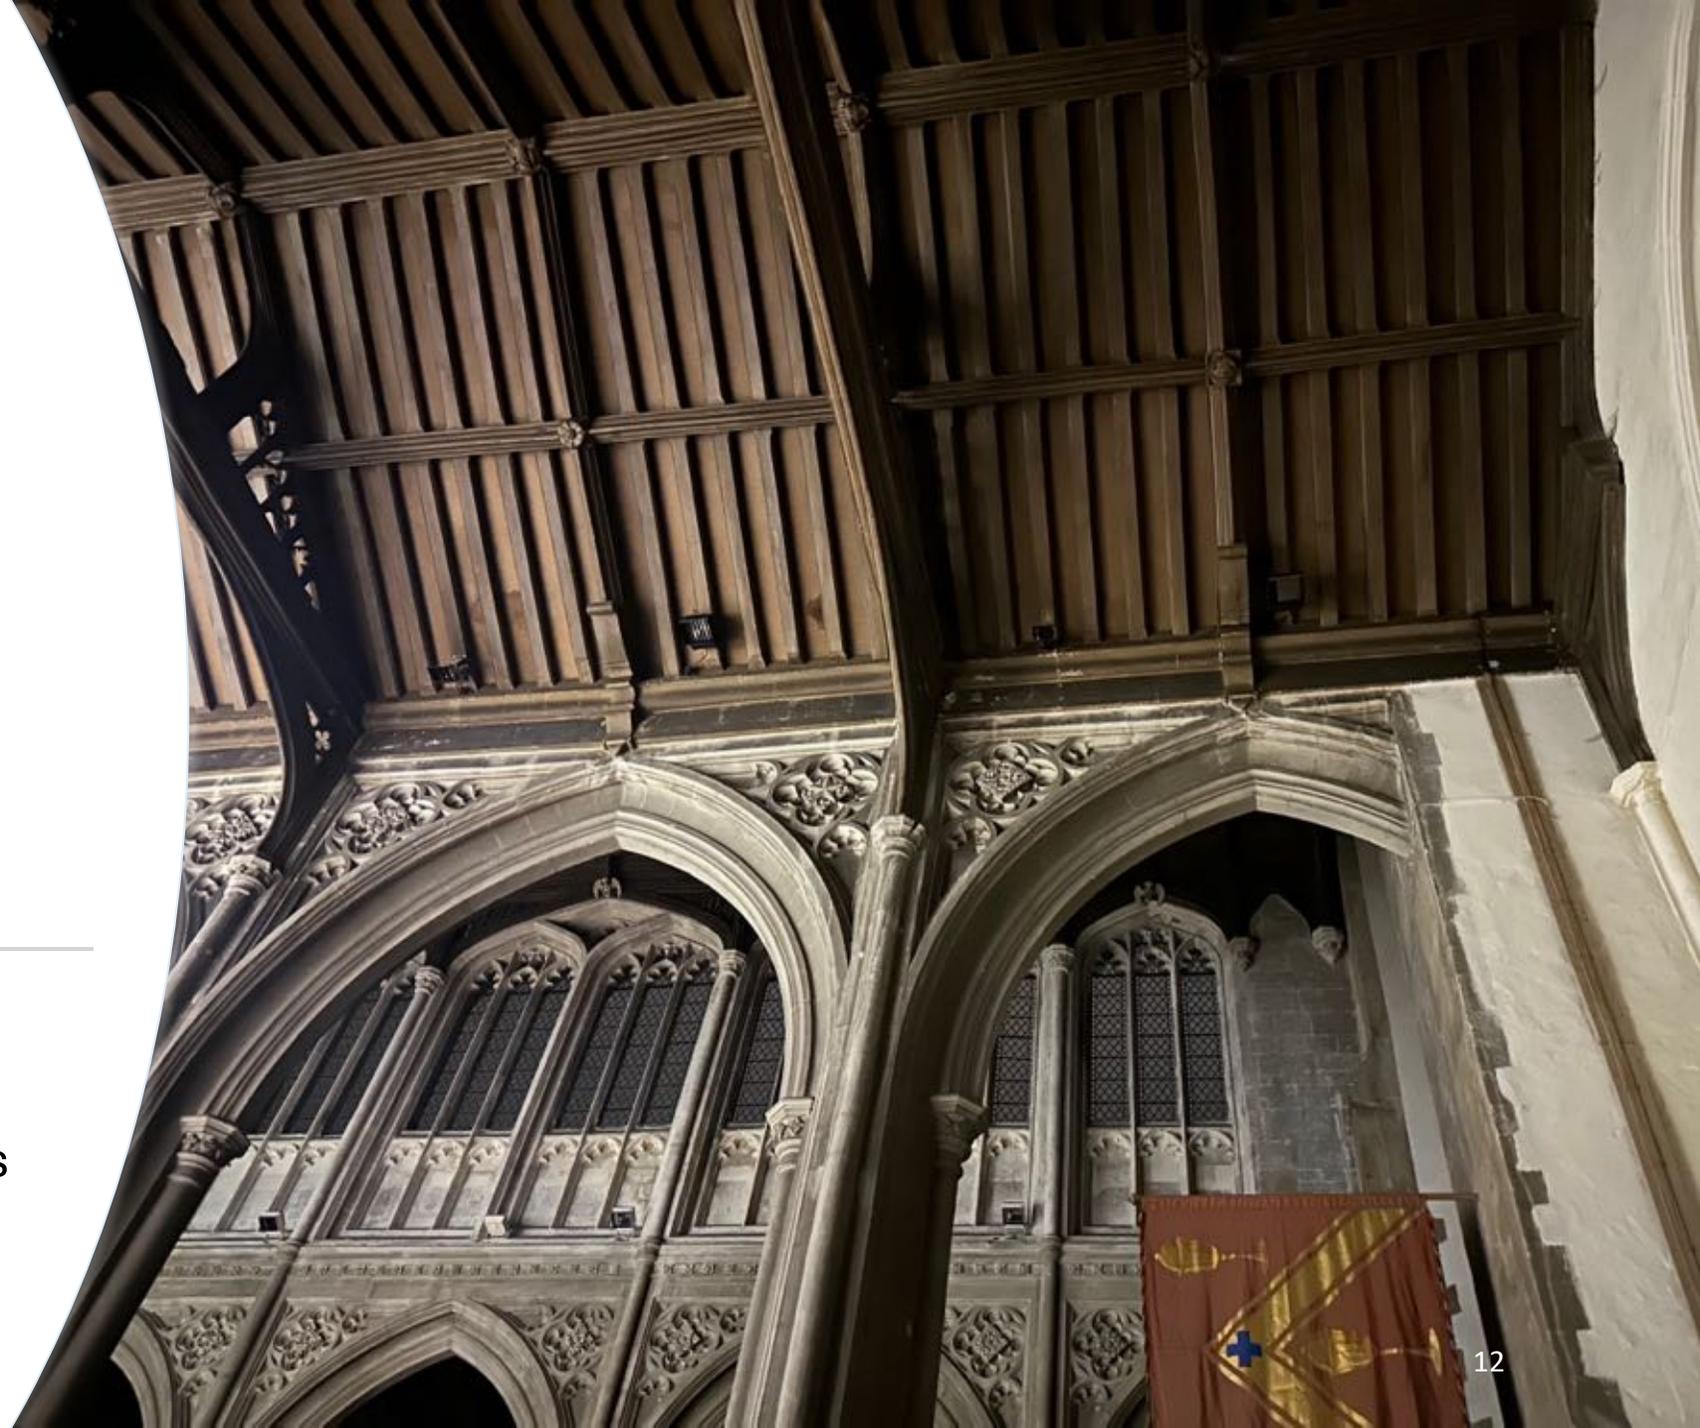
Halogens in North West Corner

- Halogen lighting bulbs removed approx. 8 years ago due to “explosion” risk
- Halogens were the only lights to come on immediately

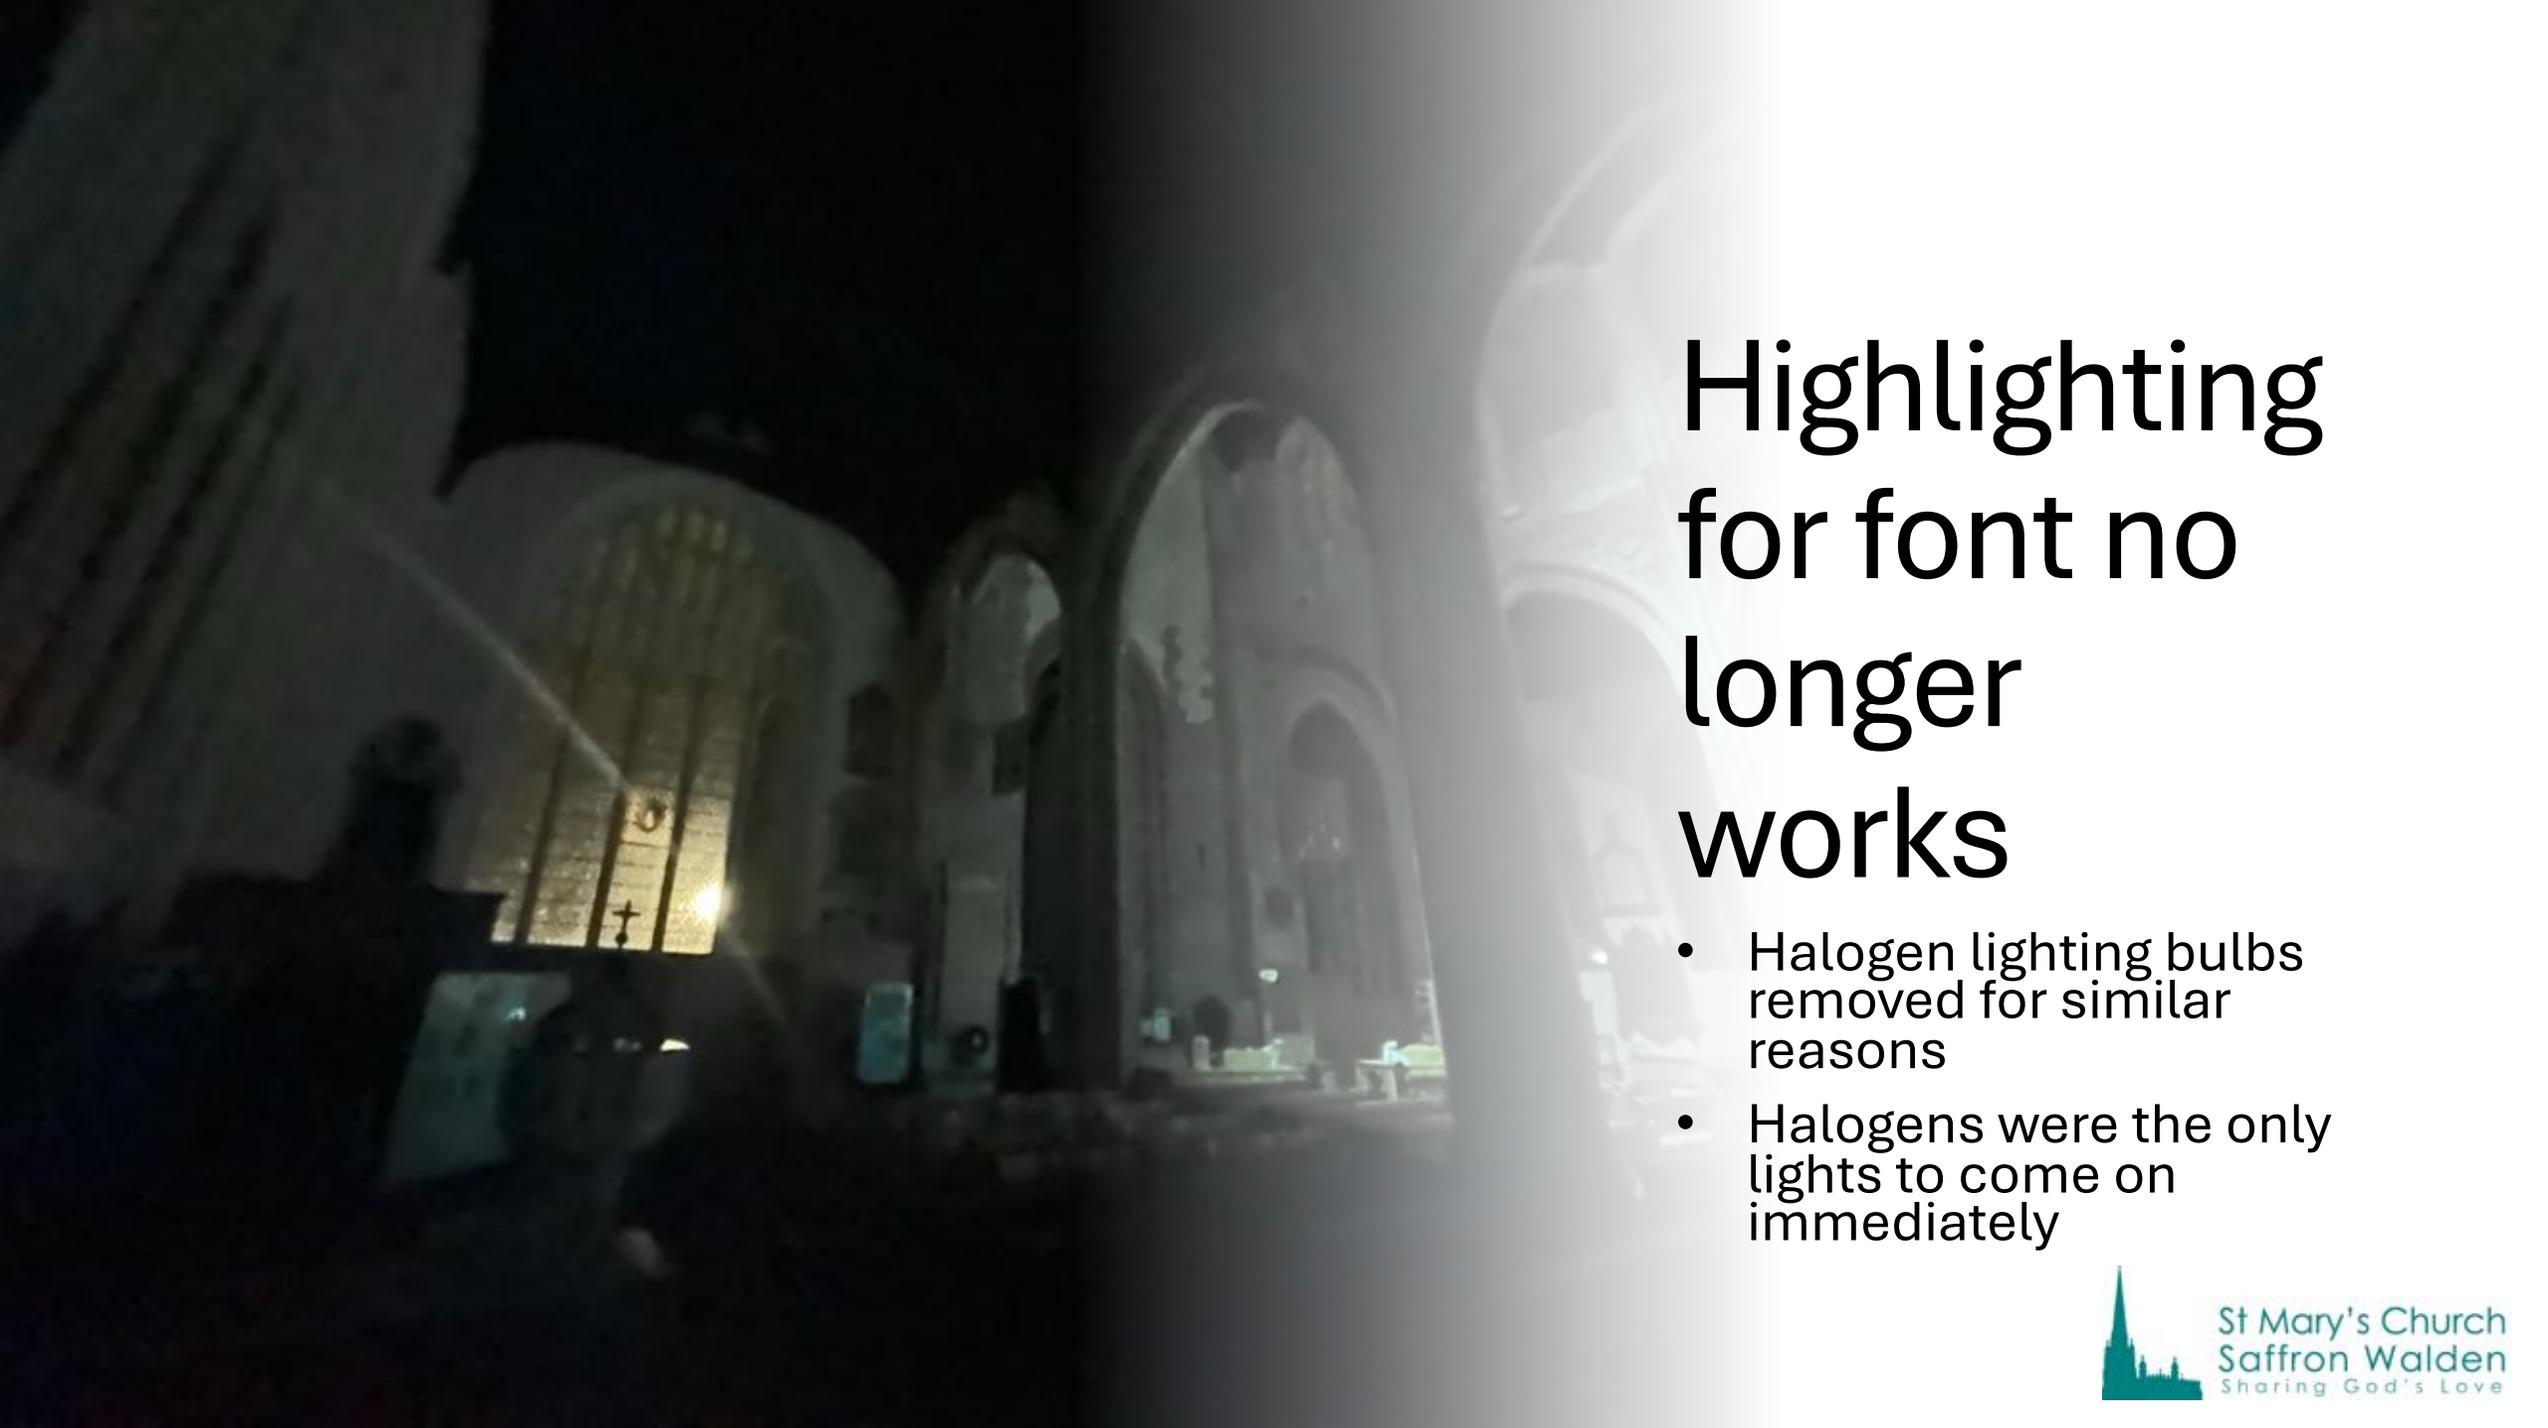
Highlighting for font no longer works

- Halogen lighting bulbs removed for similar reasons
- Halogens were the only lights to come on immediately
