Let There Be Light¹

Proposed New Lighting
St Mary the Virgin
Saffron Walden

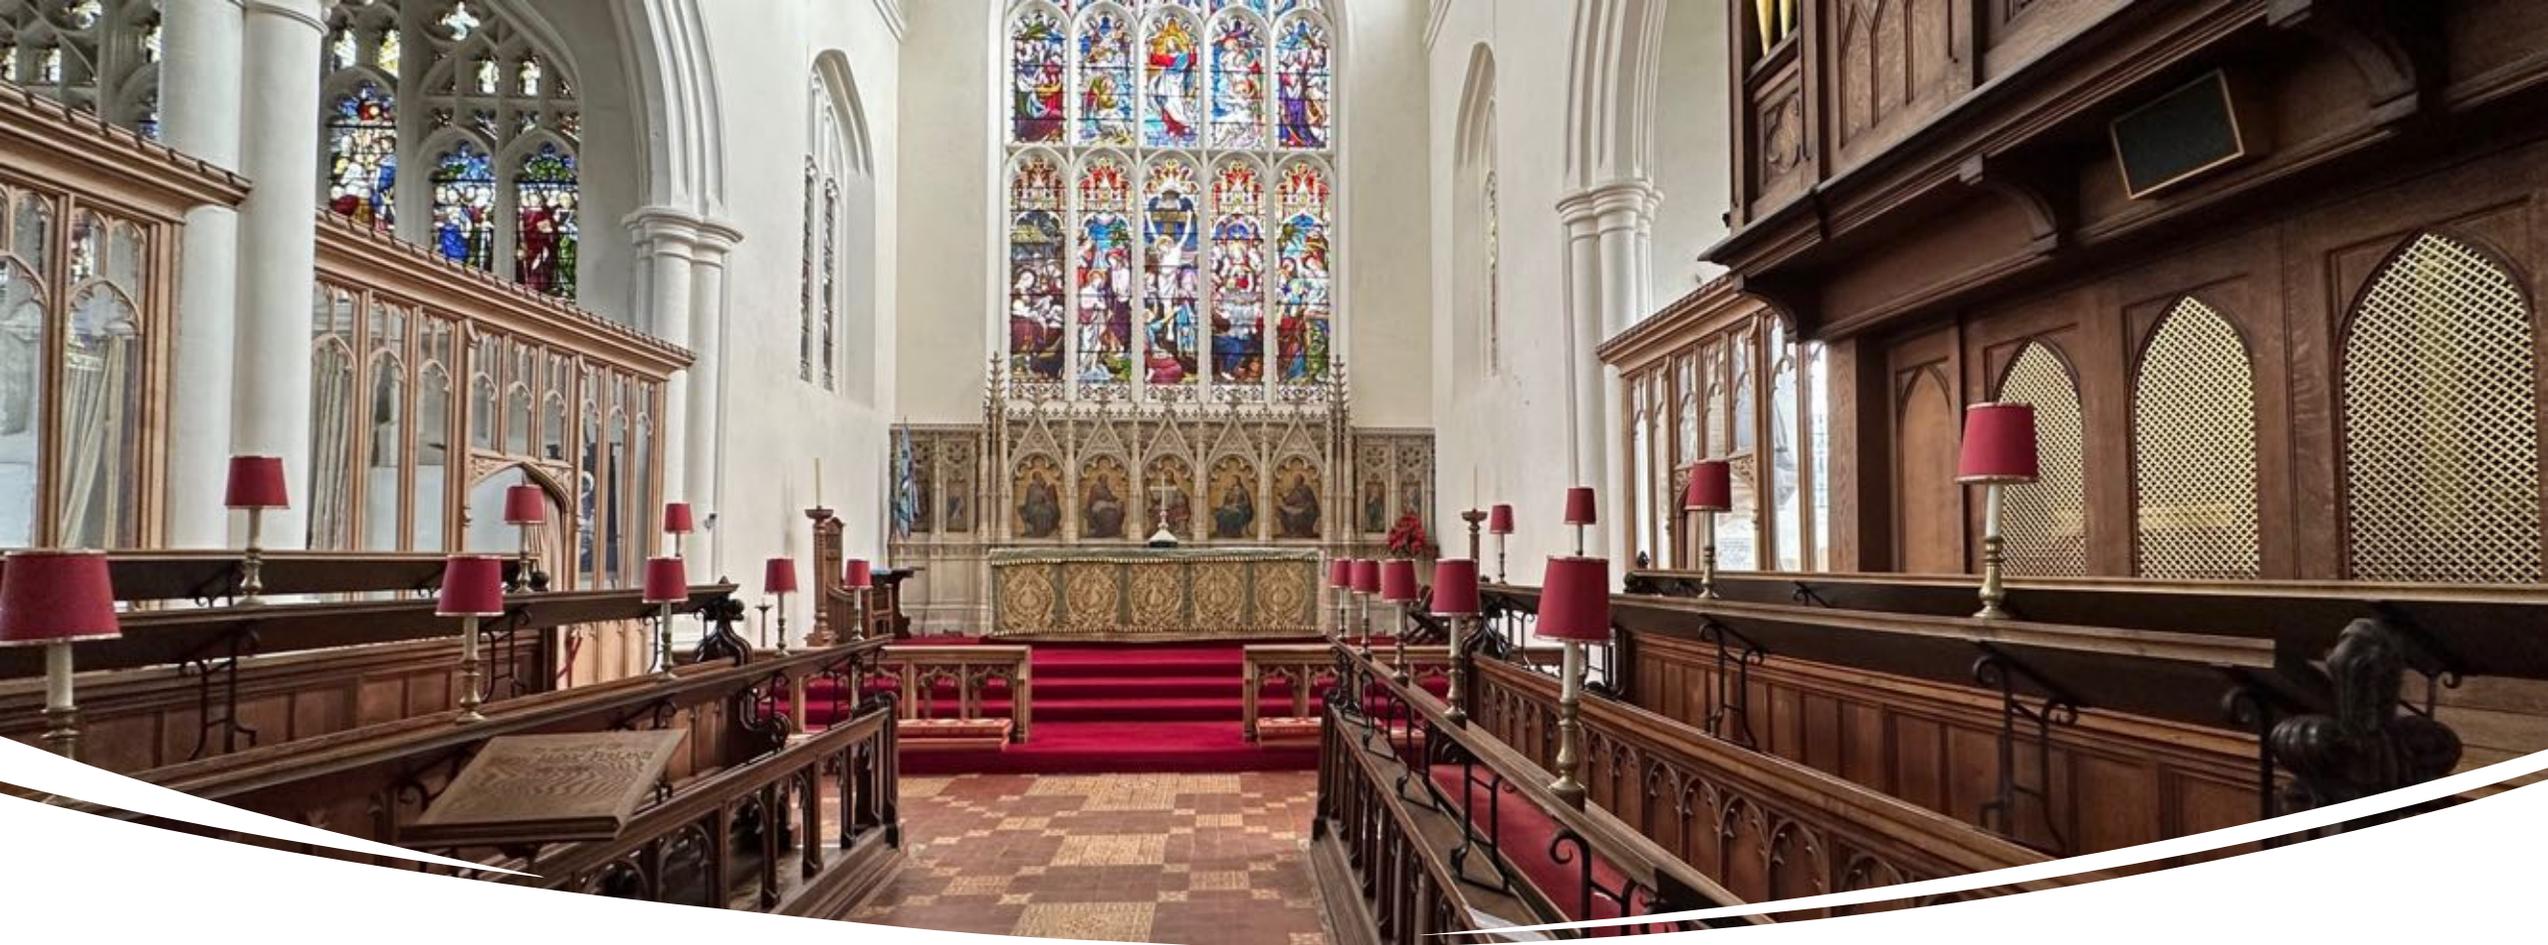
Choir Stall Lighting

- None in back rows

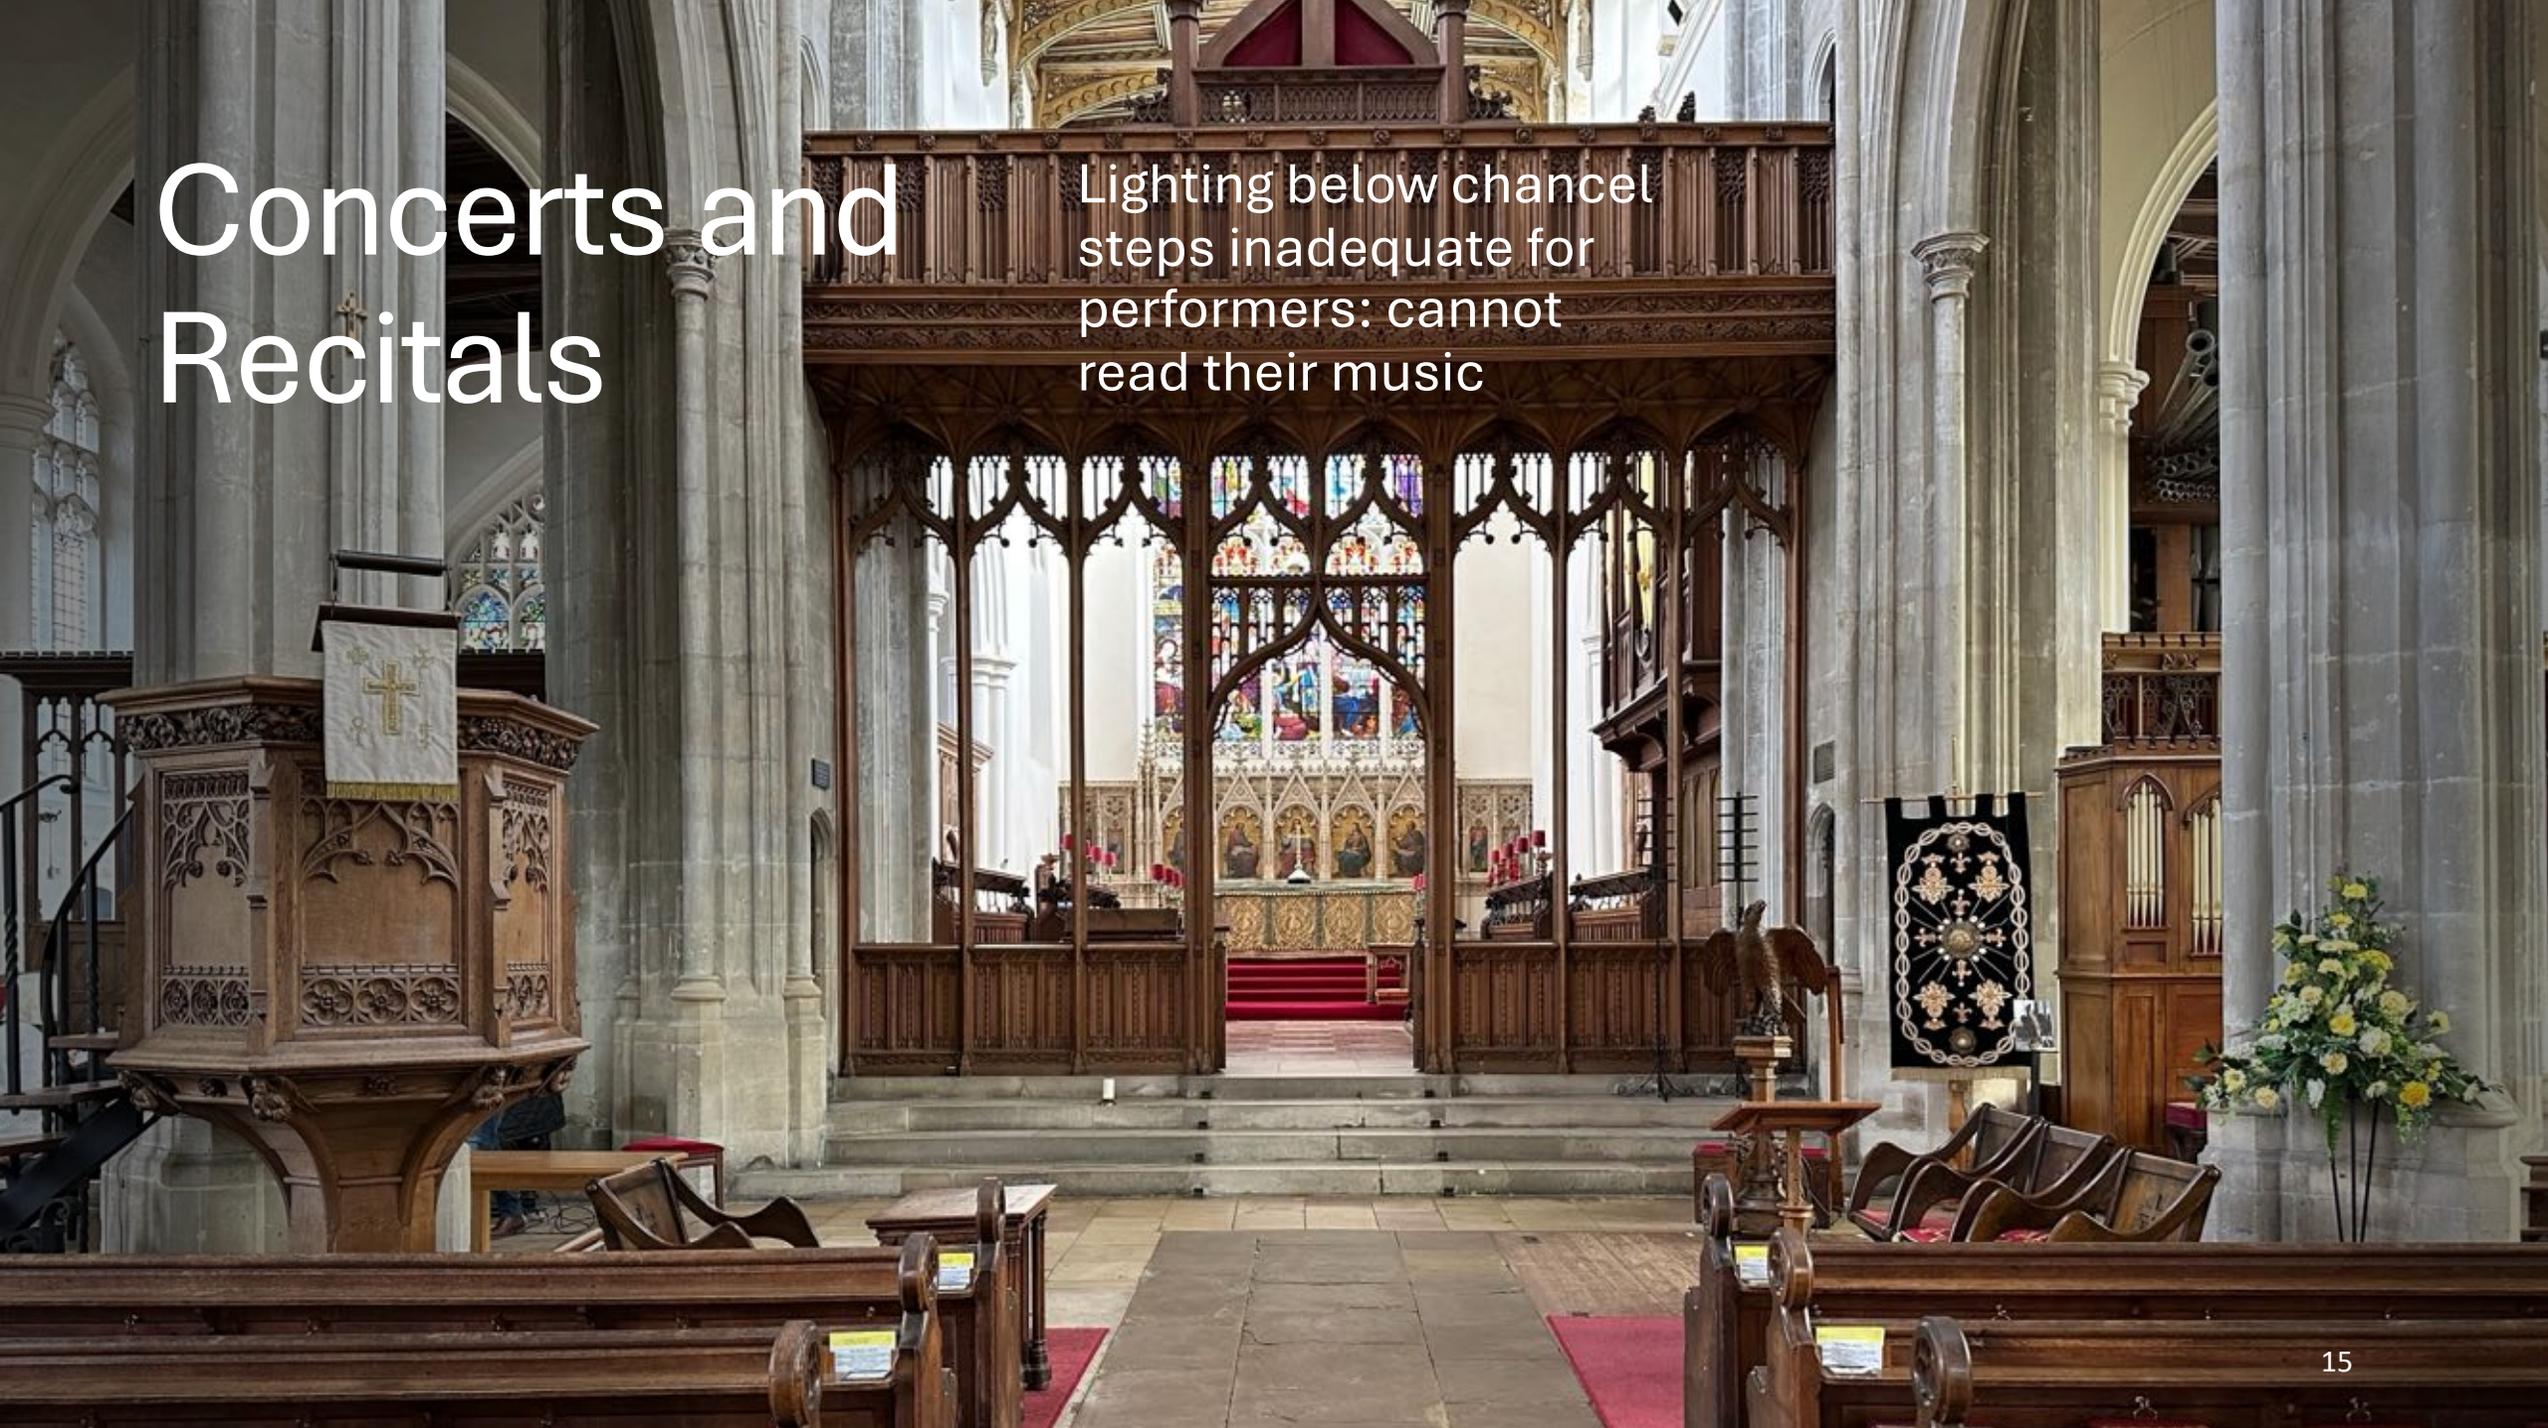
Concerts and Recitals

Lighting below chancel steps inadequate for performers: cannot read their music

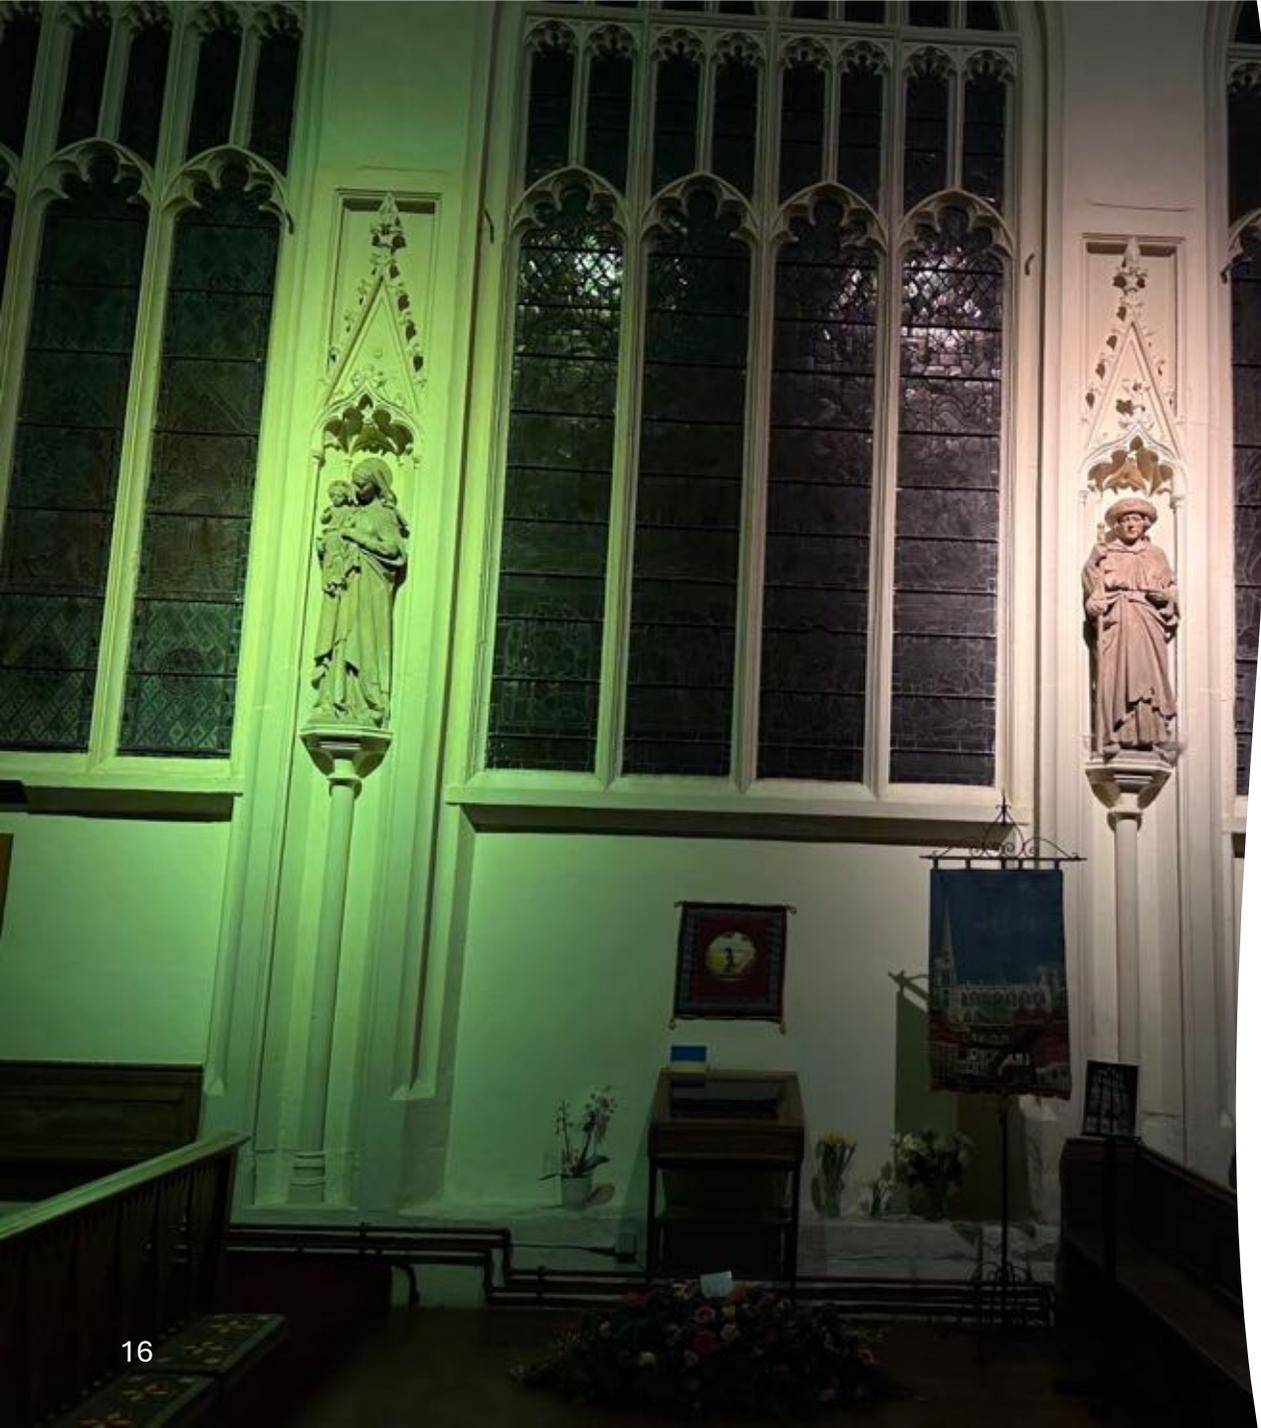
Our Green Statue

- Failed electronics!

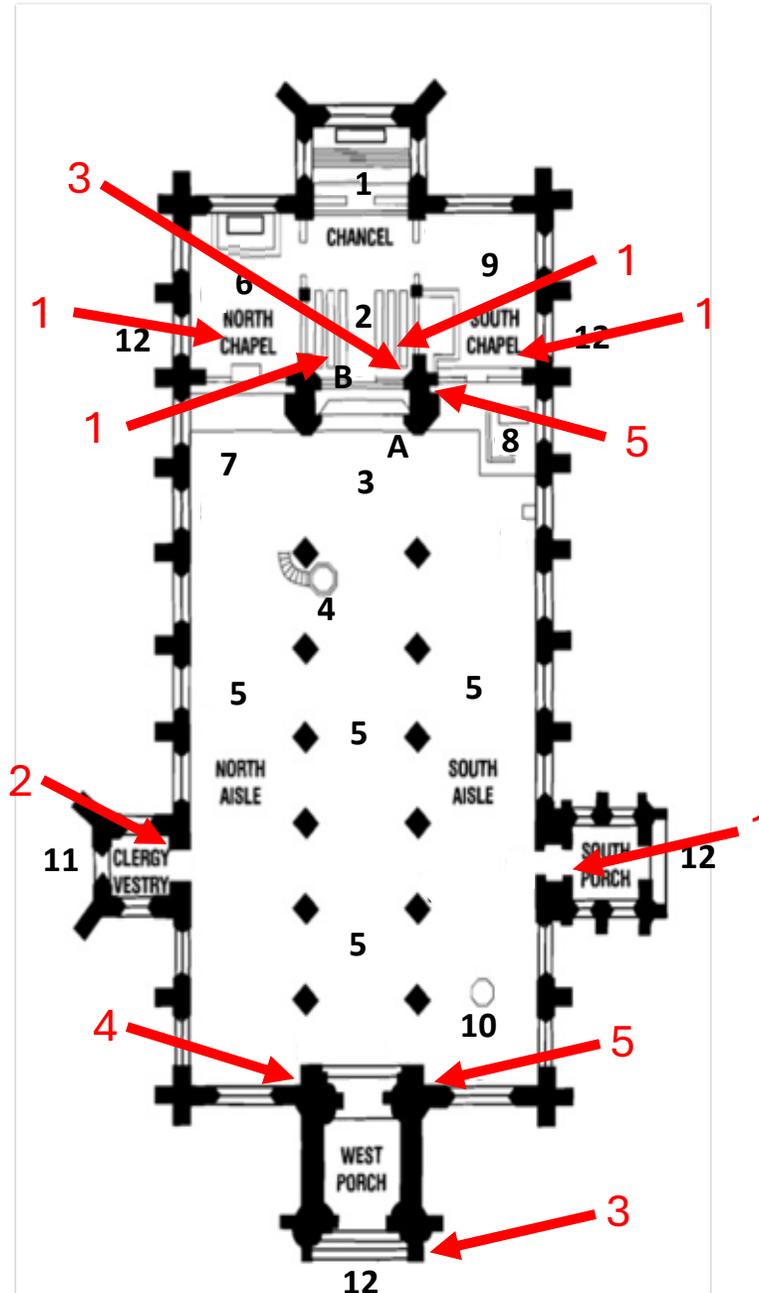
Controls

- 25 switches distributed throughout the church
- Difficult to manage and resource for special services
- No lighting for visitors
- This can be simplified!

- Pre-assigned button for each lighting scheme
- Re-programmable
- Auto switch on and off for visitors
